Assessing the Impacts of Dairy Operations on Groundwater at the UT Little River Animal Agriculture Environmental Research Unit in East Tennessee

Robert W. Hunter
September, 2012

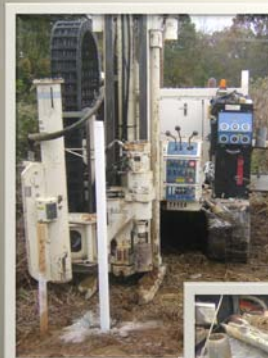
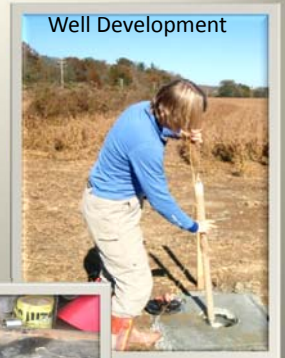
Alluvial Floodplain Well Installation

15 wells installed

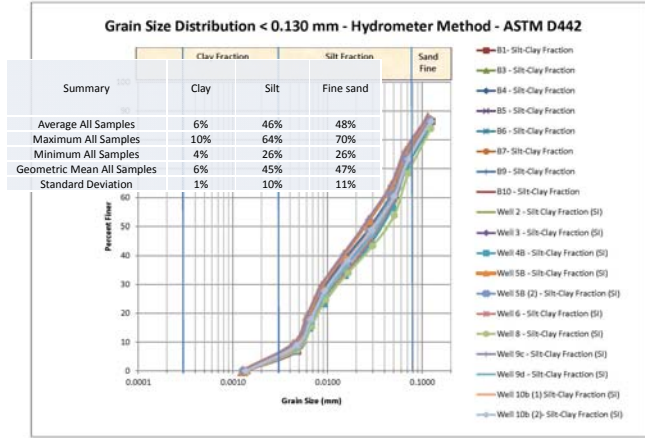
19 Composite Samples from Soil & Well Borings

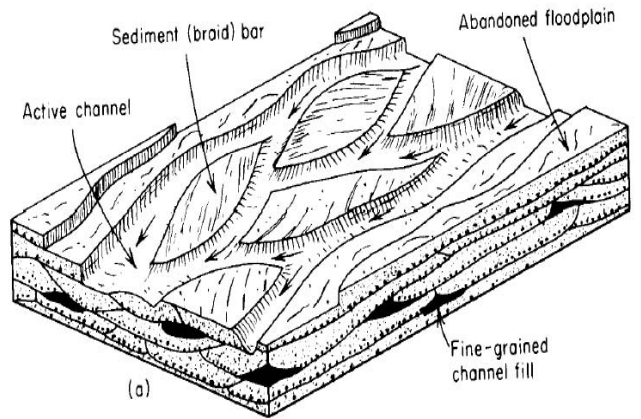
Floodplain Alluvium Stratigraphy

Alluvial River Bed Cartoon - Freeze & Cherry 1979

- Fine- to med-sands, moderate hydraulic conductivity (10 -5 m/s)
- Most flow systems are shallow, with discharge to Little River, Ellejey Creek & central drainage ditch
- Deeper flow into karst bedrock in southeast portion of LRDF

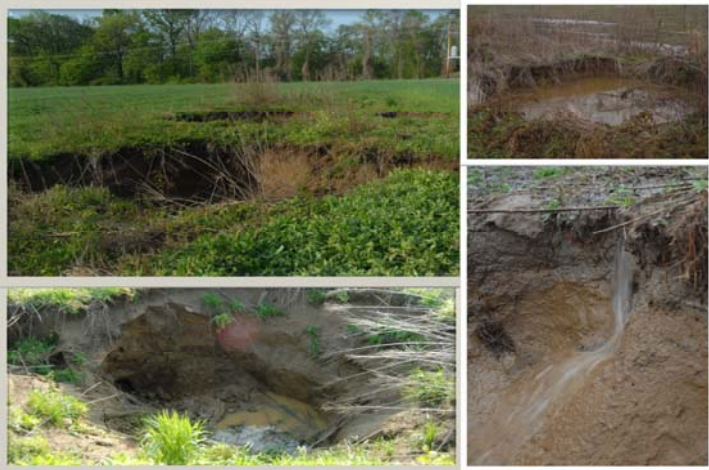
Surface and Groundwater Interactions
Active Sinkhole Development

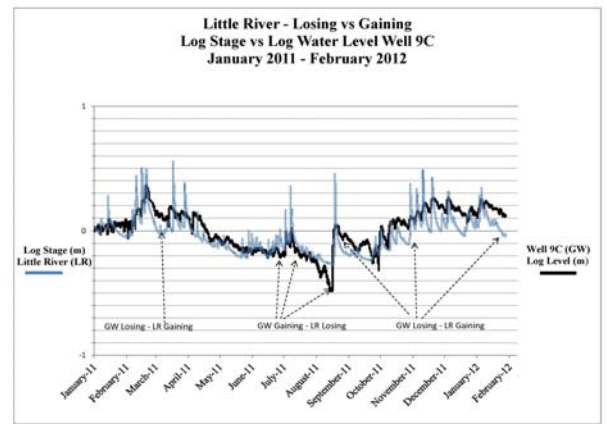
Little River - Losing vs Gaining
Log Stage vs Log Water Level Well 9C
January 2011 - February 2012

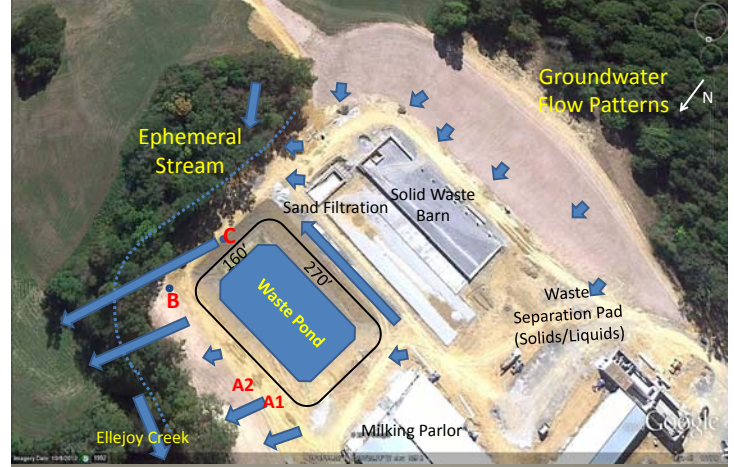
Bedrock Wells & Groundwater Flow Patterns Shale Shot Rock, Weathered and Fractured Shale

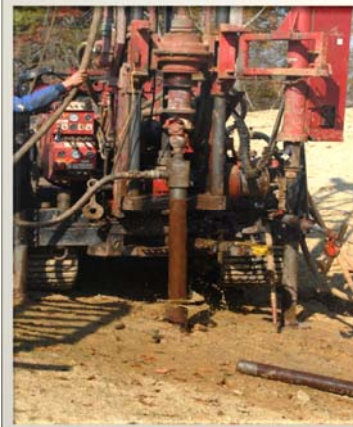
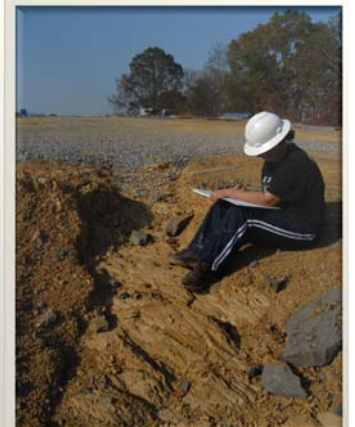
2010 Well Installations in Weathered Shale Adjacent to Manure Waste Pond

- Highly weathered & fractured
- Hydraulic connection to waste pond
